1. Report No. SSRP-2001/25	2. Government Accession No.	3. Recipient's Catalog No.	
4. Title and Subtitle SEISMIC DESIGN AND PERFORMANCE OF PRECAST CONCRETE SEGMENTAL BRIDGE COLUMNS		5. Report Date May 2002

6. Performing Organization Code	
7. Author(s) Joshua T. Hewes and M. J. Nigel Priestley		8. Performing Organization Report No. UCSD / SSRP-2001/25	
9. Performing Organization Name and Address  Department of Structural Engineering School of Engineering University of California, San Diego La Jolla, California 92093-0085		10. Work Unit No. (TRAIS)

This research involved the investigation of the performance of unbonded post-tensioned precast concrete segmental bridge columns under lateral earthquake loading. Two columns with a high aspect ratio and two columns with a low aspect ratio were tested under simulated lateral seismic loading. Steel jackets of different thickness were used to confine the plastic end region at the base of each column. The specimens all contained the same amount of prestressing steel and each was tested twice: the first time with a relatively low initial tendon stress, and the second with a higher initial prestress level. An analytical model describing the c

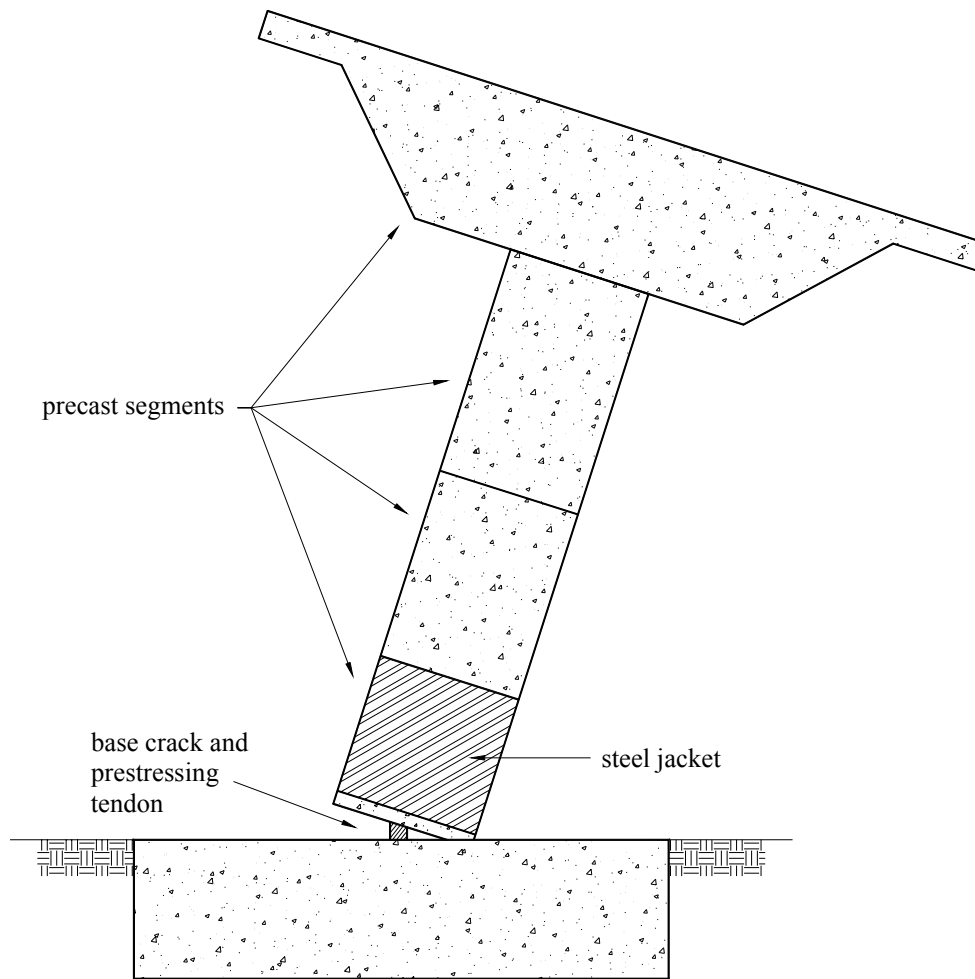
**Figure 1.1 Idealized Transverse Column Response**

The seismic performance characteristics described above are a direct consequence of the unbonded tendon design. A schematic of column response in the transverse direction is shown in Figure 1.1. As the precast column displaces laterally under earthquake excitation, a wide flexural crack is formed at the interface between the column base and the foundation as the column rotates rigidly about its compression toe. The prestressing steel is stretched once the base crack opening extends to the location of the tendon. Since the tendon is unbonded over the height of the column, incremental strains are not concentrated at the crack and if the initial prestress level is carefully selected, inelastic straining of the prestressing steel does not occur. This is important for several reasons. First, the ability to transfer shear across the component interfaces by shear friction is dependent on the clamping force provided by the prestressing tendon. The column stiffness is also reliant on the prestressing force and hence is not reduced drastically if the prestress is maintained. Finally, the restoring force provided to the column by the prestress is maintained during and after the earthquake ensuring that the column returns to the undeformed position.

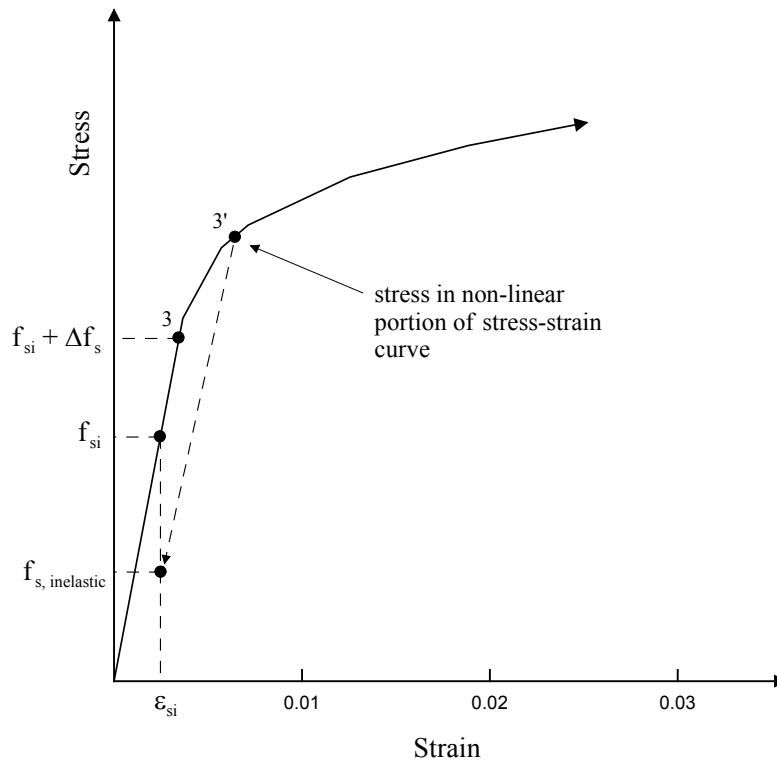
Figure 2.2.2 Prestressing steel stress-strain behavior

As seismic forces increase, a crack will form at the column base and begin to propagate into the section depth. Eventually the base crack will reach mid-depth of the section. This condition defines the second stage of column response as it represents the beginning of significant nonlinearity in response. With a further decrease of neutral axis depth, the prestressing tendon is stretched and the steel stress will increase by  $\Delta f_s$ . Fluctuations in steel stress during the seismic event will remain in the elastic regime if the initial stress,  $f_{si}$ , is carefully selected (point 3 in Fig. 2.2). If however the initial stress is too high, or if the maximum column displacement is larger than expected, the steel stress may enter the inelastic portion of the stress-strain curve (point 3' in Fig. 2.2). Upon unloading to the undeformed position, the effective stress will be reduced to  $f_{s,inelastic}$ . The consequence of this is partial, or in the extreme case complete loss of the tendon prestress force. Since the ability to transfer shear between precast segments is dependent on the clamping force provided by the prestressing tendon, it is vital that the designer can accurately predict the prestressing steel stress increase under seismic input.

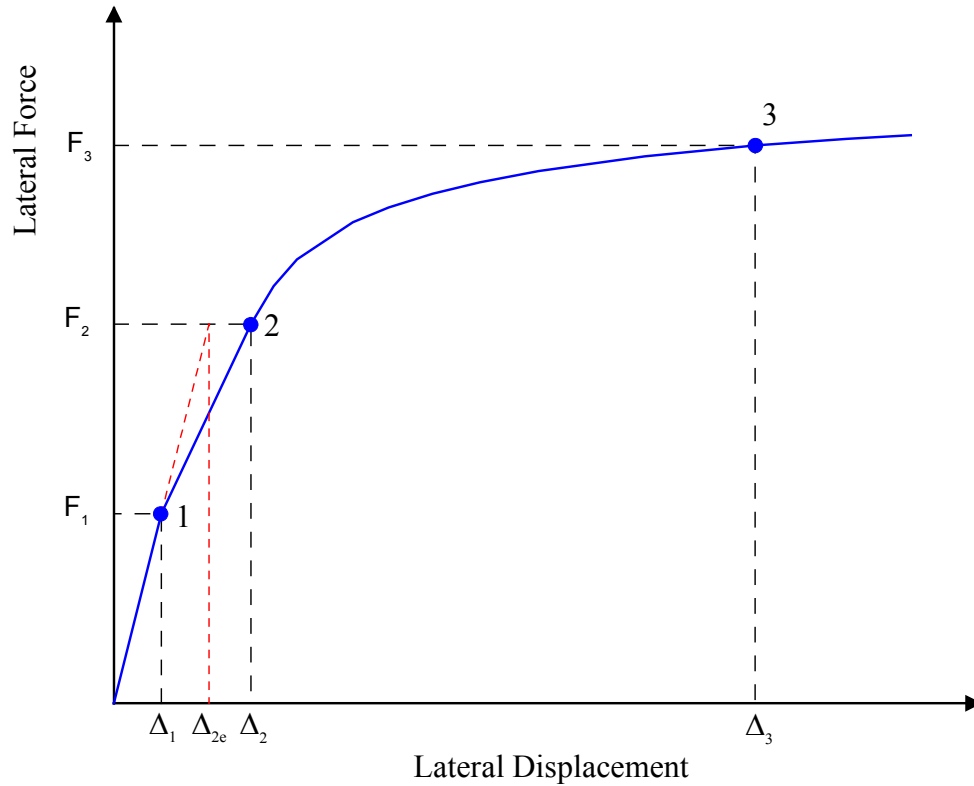
Figure 2.2.5 Force – displacement response envelope

Point 2 corresponds to the stage when the crack at the column base has propagated to mid-depth of the section, and is taken as the yield point of the force-displacement response. It should be noted however, that the word “yield” is not meant to reflect any yielding of the prestressing steel reinforcement, but rather is used to describe the point where significant nonlinearity in column response begins.

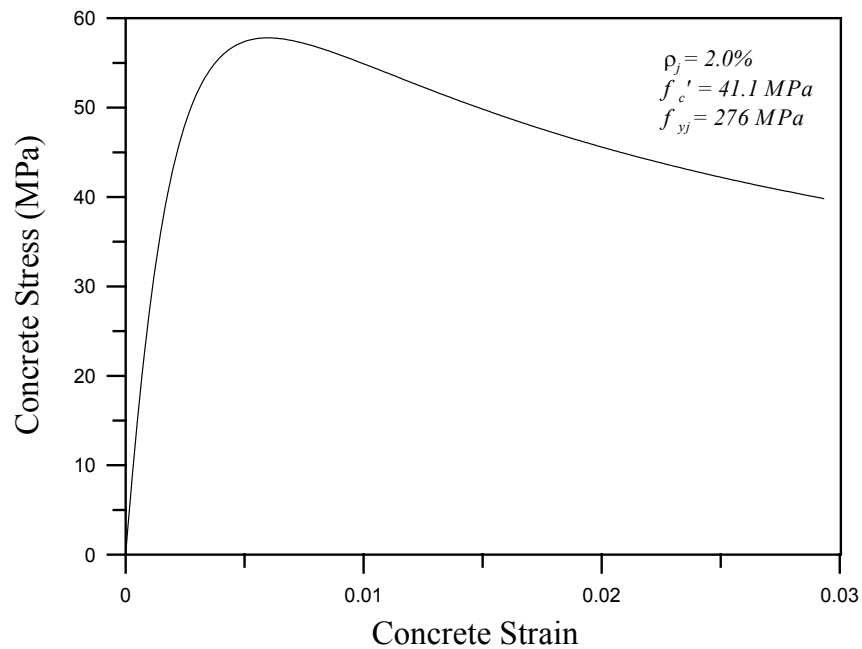
Figure 2.6 Mander model for confined concrete stress-strain relationship

The model for the stress-strain behavior of confined concrete proposed by Mander *et al.* [4] has been used widely and has been incorporated into moment-curvature software programs designed for conventionally reinforced concrete columns. This model was used in the moment-curvature analysis described previously. Figure 2.6 shows a representative stress-strain curve for a volumetric confinement ratio of  $\rho_j = 2.0\%$ , unconfined concrete compressive strength of  $f'_c = 41.4\text{MPa}$ , and steel yield strength of  $f_{yj} = 276\text{ MPa}$ .

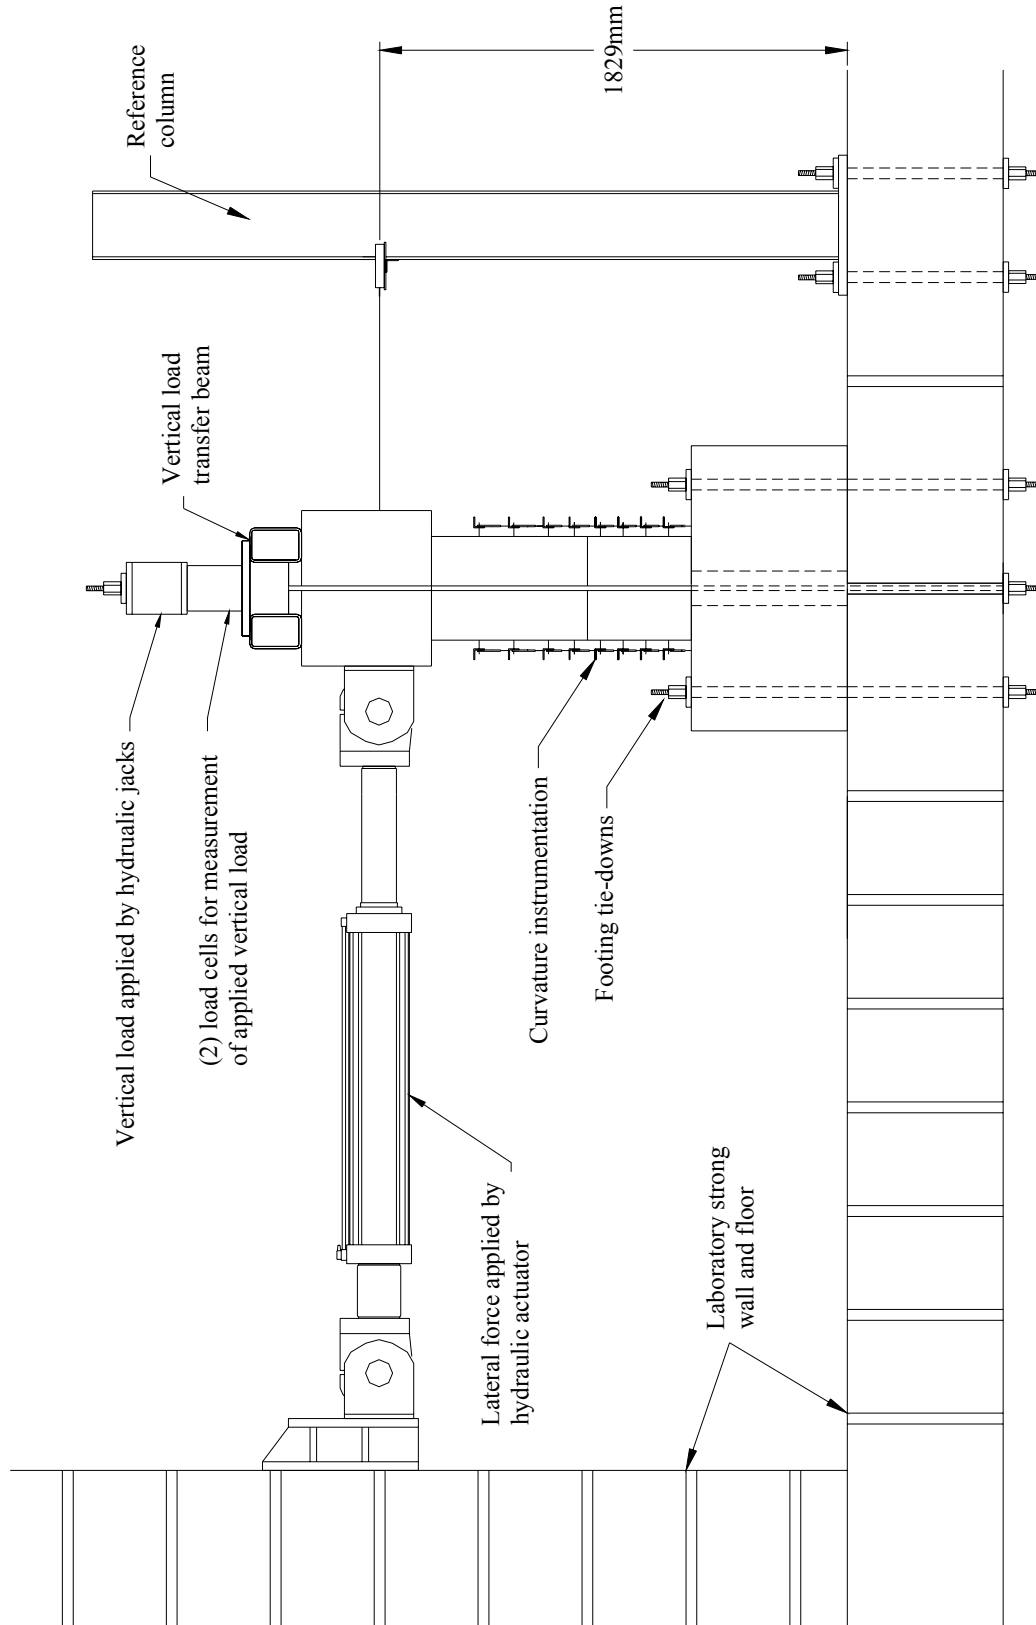
Figure 3.3 Schematic of test set-up for specimens JH3 and JH4

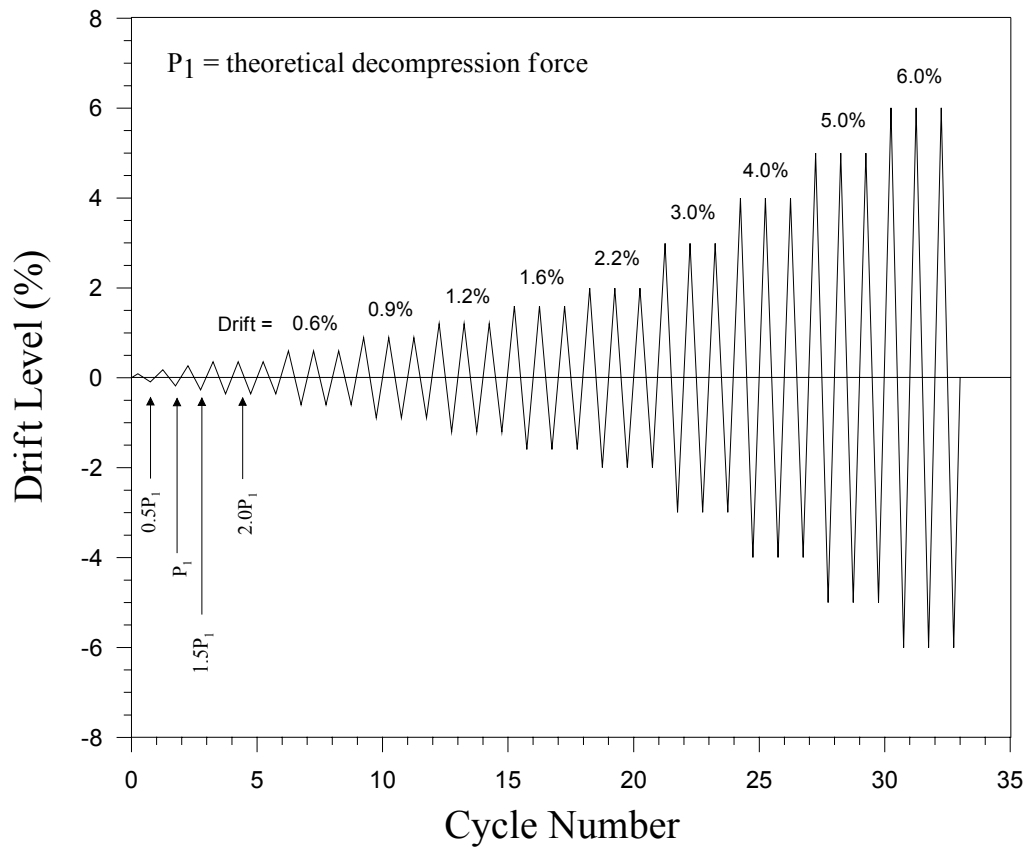
Figure 3.5 Lateral loading sequence for the first and second test of each unit

The loading sequence utilized for the tests is shown graphically in Figure 3.5. The first few cycles of each test were conducted in the elastic range under load control, with one cycle each performed at one-half, one, and one and a half times the theoretical load to cause decompression of the extreme tension fiber of the section at the column base,  $P_1$ . Subsequent cycles during the test were conducted in displacement control. Since each column was to be tested twice, it was desired to limit the damage in the first test of each column to an amount that could be repaired relatively easily (i.e., epoxy injection of residual cracks and patching of spalled cover concrete). Thus, the maximum drift imposed during the first test of each specimen was dictated by the observed damage at a particular drift. The column drift is defined as the displacement at the level of the applied load divided by the column height to the applied load:

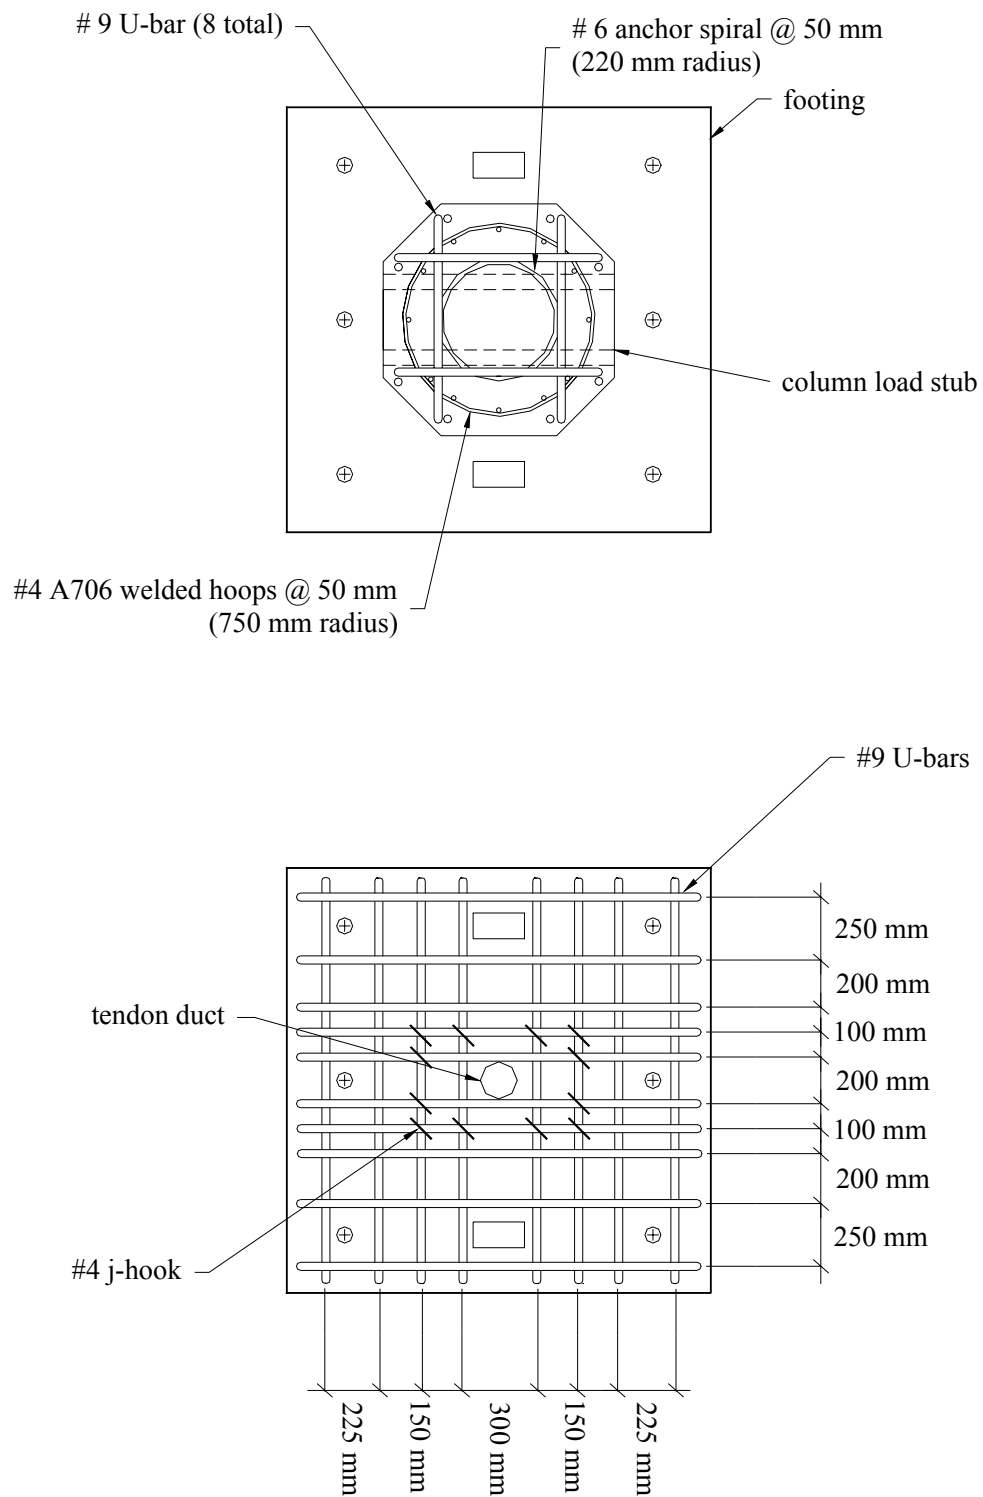
Figure 4.2 Specimen JH1 and JH2 footing and load stub reinforcement details

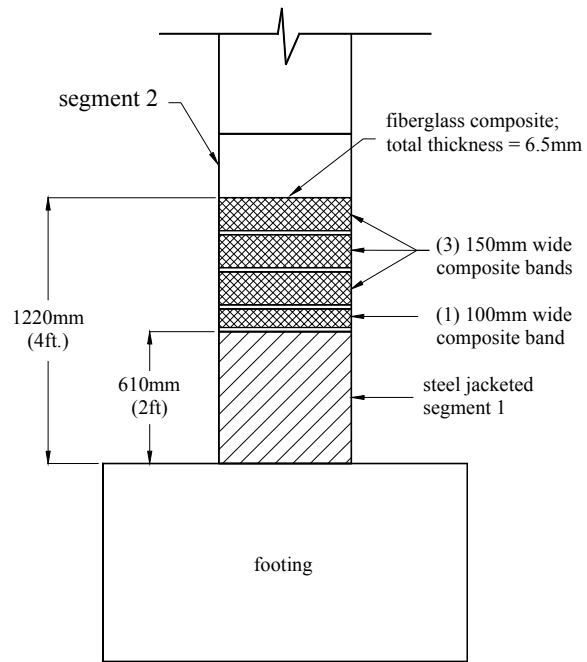
Figure 4.3 Composite wrap details

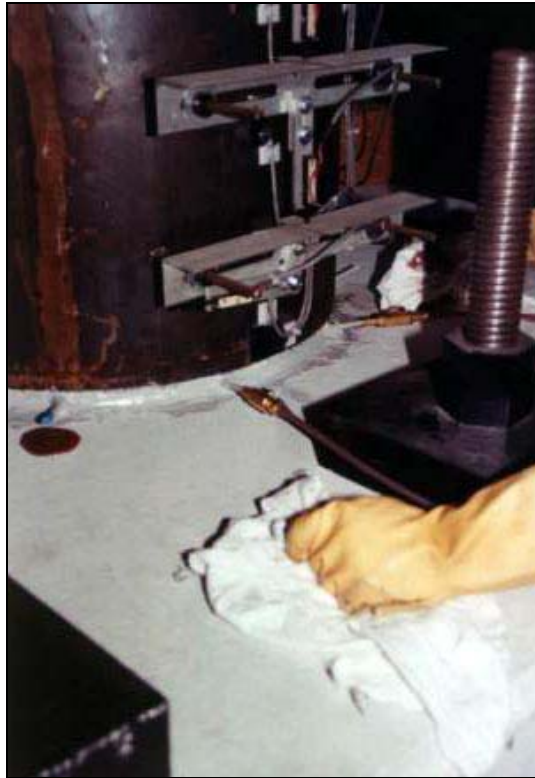
Figure 4.15 Close-up of grouting of the base residual crack

The damaged regions at the column base and above the jacket were repaired after the first test of each specimen. Loose concrete was removed and the regions scrubbed with a wire brush. The areas were rinsed with water to remove any remaining concrete particles and then allowed to dry. The spalled concrete above the steel jacket at the base of the second column segment was reinstated by patching the area with SikaTop 123 – a polymer-modified, Portland cement, 2-component, fast-setting, non-sag patching mortar. The residual crack at the column base was grouted using Sikadur 35 – a high-modulus, low-viscosity, high-strength epoxy resin adhesive. Figures 4.15 and 4.16 show the base crack during the grouting process and the patched region above the steel jacket, respectively.

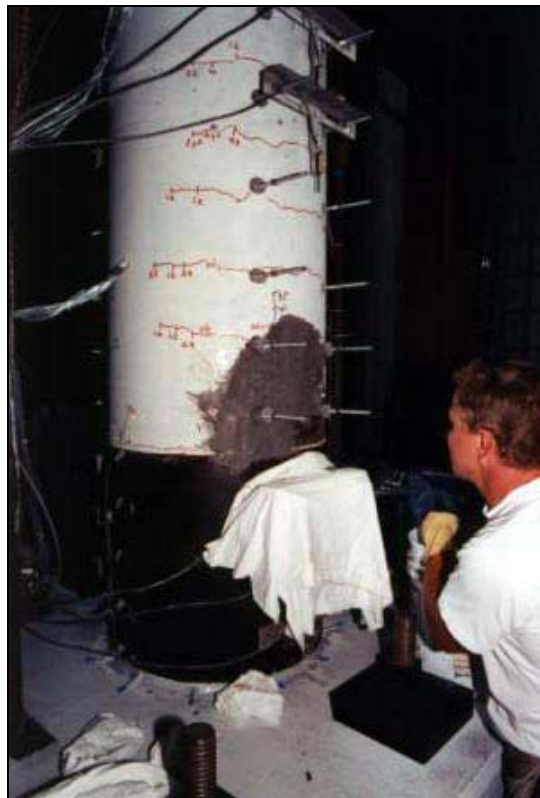
Figure 4.16 Patching of spalled region at bottom of segment 2

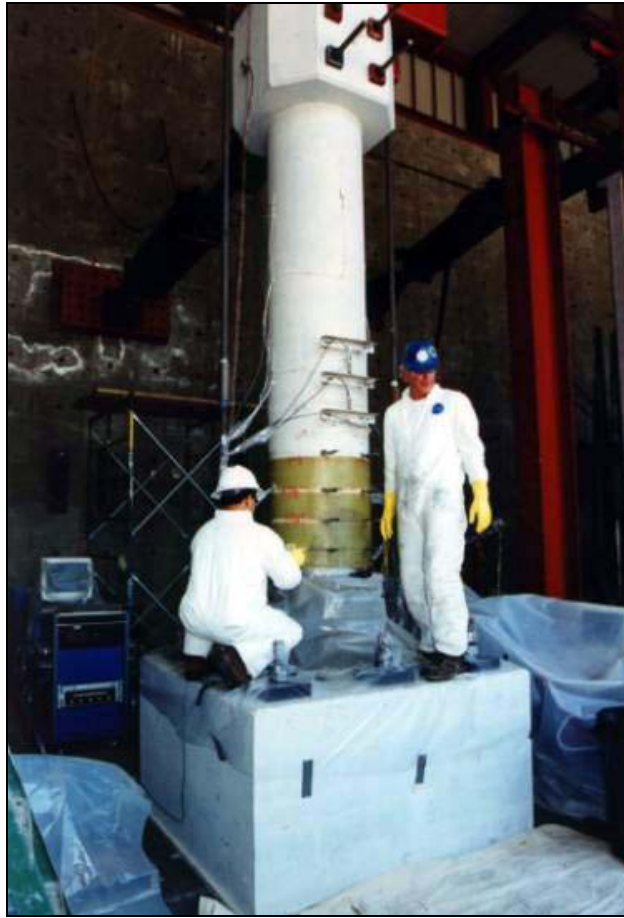
Figure 4.17 Wrapping segment two with a composite jacket

After the spalled region above the jacket was repaired, the lower half of the second column segment was wrapped with fiberglass in an effort to prevent spalling of cover concrete during the second test. Five layers of the Tyfo<sup>®</sup> Fibrwrap<sup>®</sup> SEH-51 Composite System were applied in segments in order to work around the existing curvature rods and instrumentation. Each continuous band was installed with a six-inch minimum overlap back onto itself. Figure 4.3 illustrates the layout of the fiberglass wrap, while Figure 4.17 shows the column during installation of the jacket.

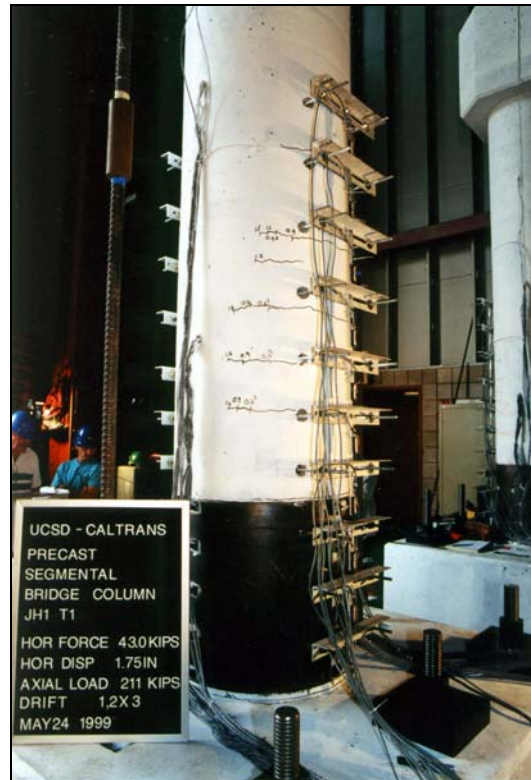
Figure 4.19 JH1 – Test 1 Crack pattern at 1.2% drift

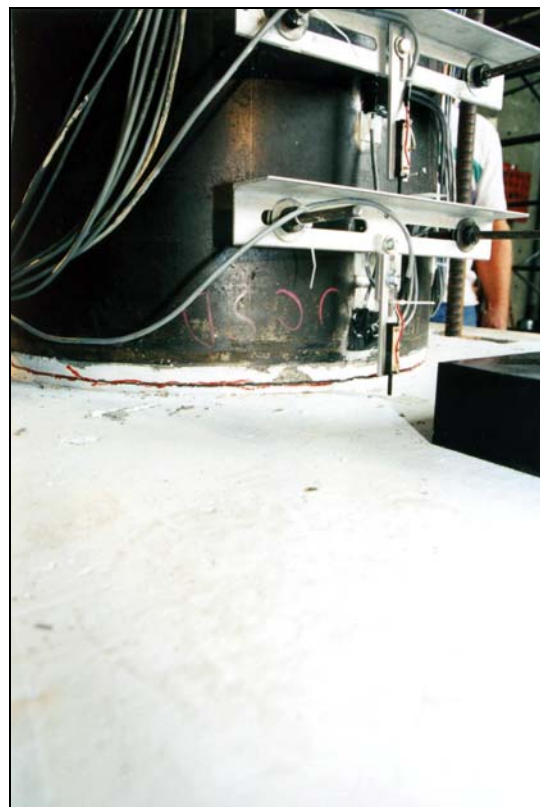
Figure 4.20 JH1 – Test 1 Spalling below jacket at 1.6% drift

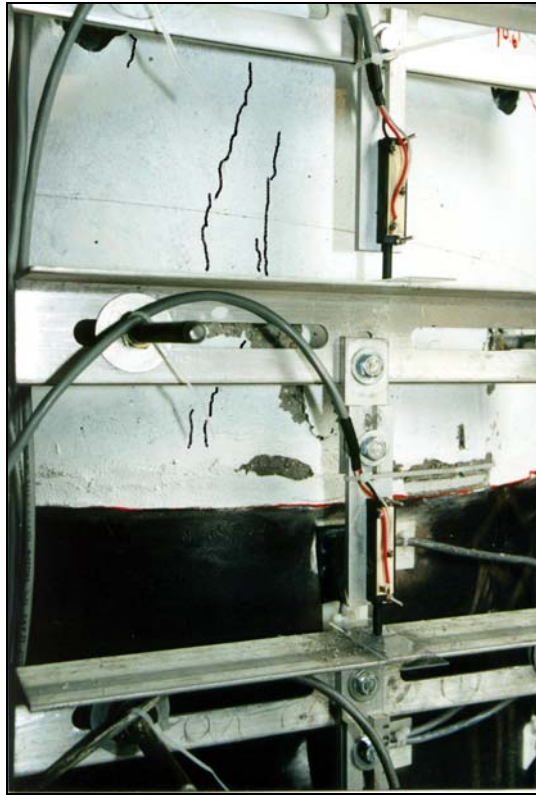
Figure 4.21 JH1 – Test 1 Damaged region above jacket at segment 3 base at 3.0% drift

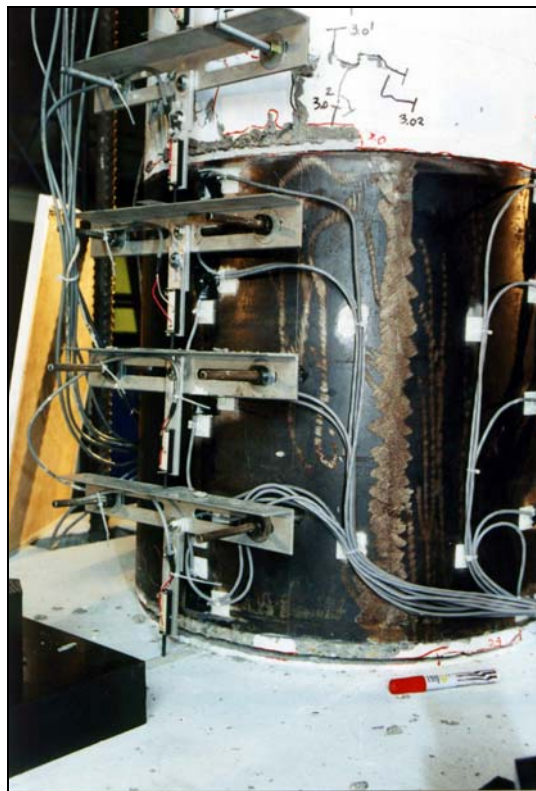
Figure 4.22 JH1 – Test 1 Crack at column base at 3.0% drift

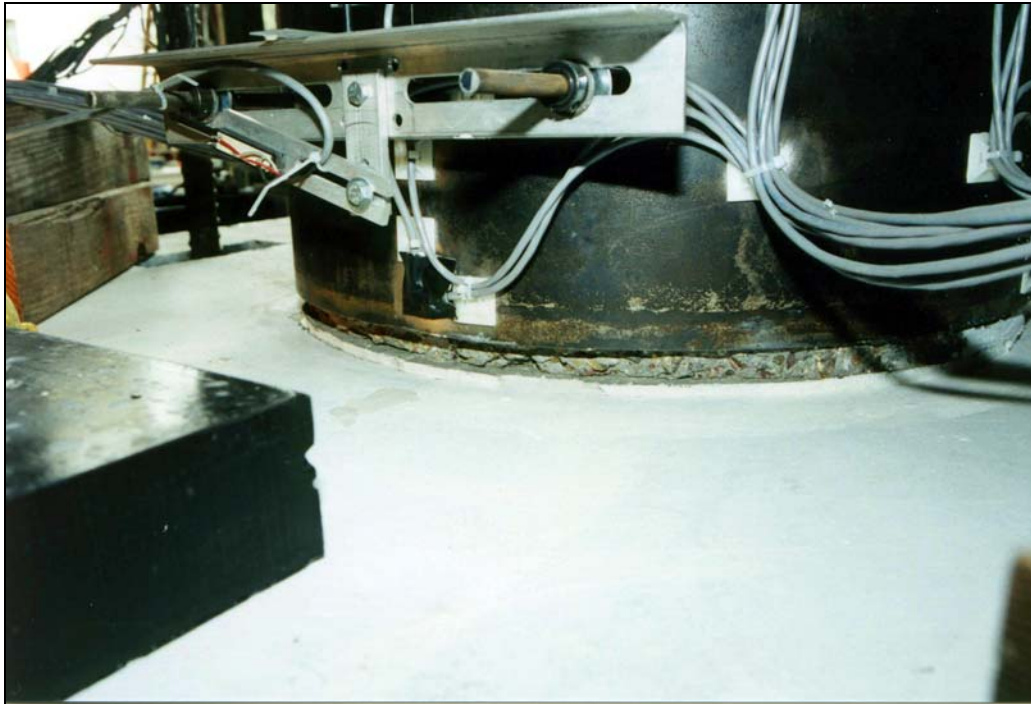
Figure 4.23 JH1 I Test 1 Damage below jacket at test end

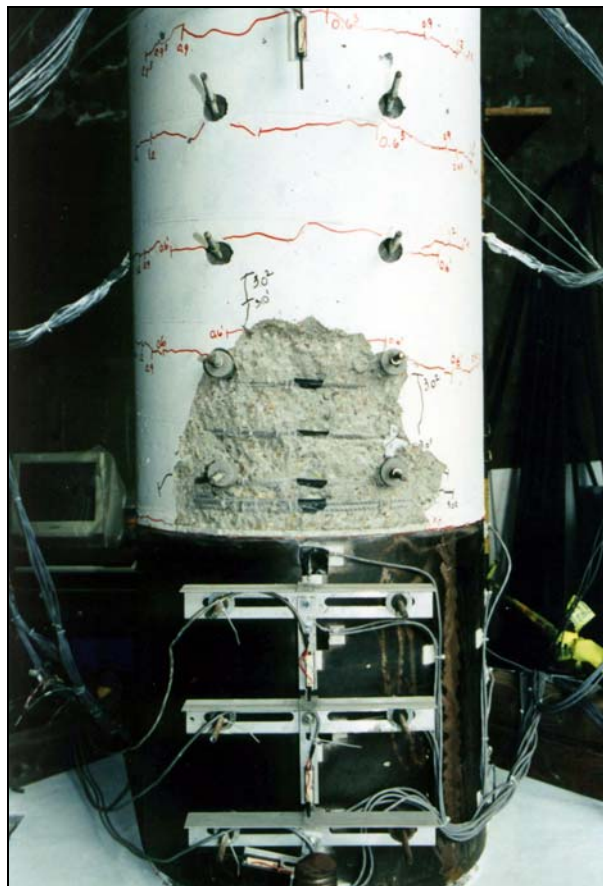
Figure 4.24 JH1 – Test 1 Spalled region above jacket at test end

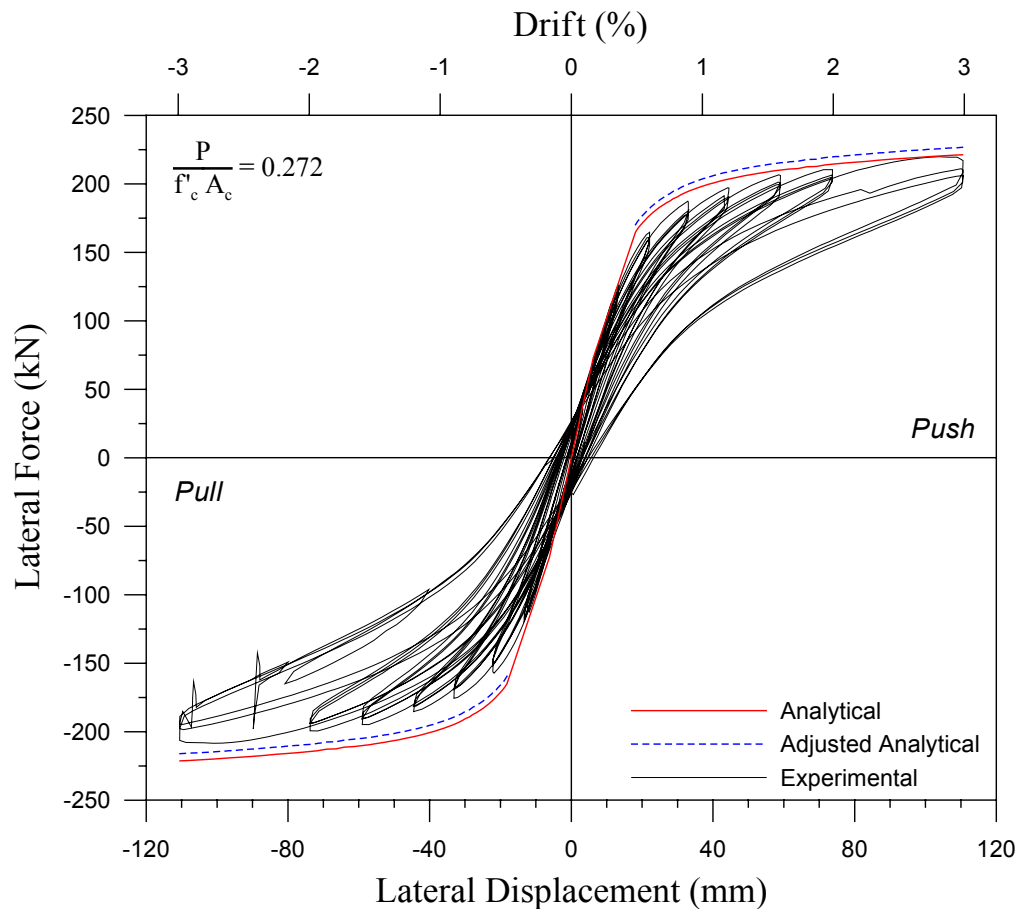
Figure 4.25 JH1-Test 1 Force-displacement response

The force-displacement response for the first test of specimen JH1 is displayed in Figure 4.25. Stable, hysteretic response was observed for both directions of loading up to the maximum imposed drift of 3.0%. Significant non-linear behavior initiated at a force level of approximately 160 kN, or 2.25 times the theoretical load to cause decompression at the column base (i.e.,  $2.25 \times P_1$ ). Maximum column strengths were achieved at the maximum imposed drift of 3.0% and were 217.0 kN and -206.3 kN for the push and pull loading directions, respectively. Though the response was stable throughout the test, there can be seen two spikes of the force for the negative direction of loading at 3.0% drift. These spikes occurred during unloading from the third pull cycle at test end and were a result of actuator instability.

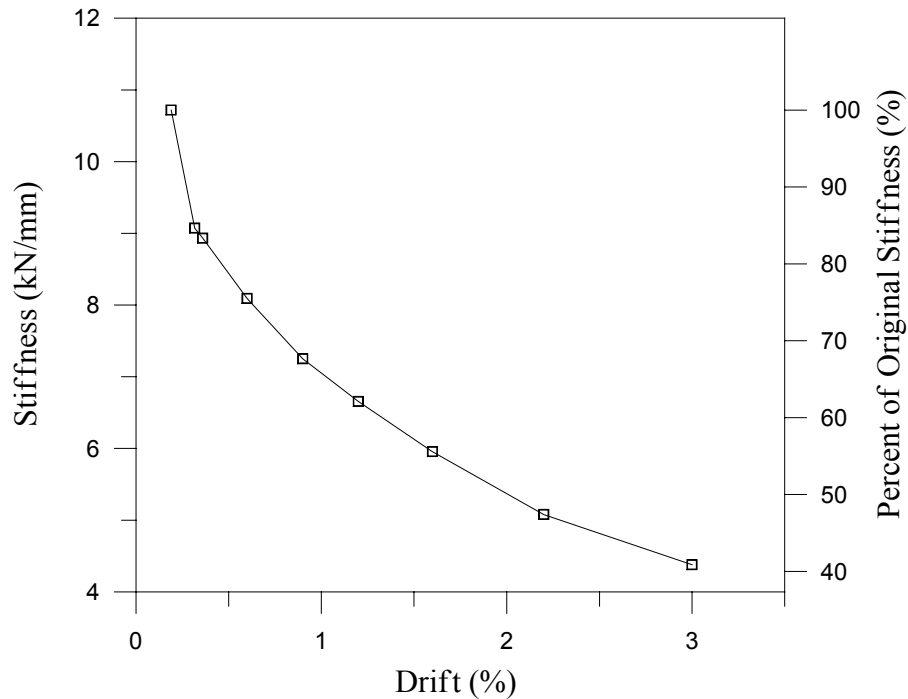
Figure 4.27 JH1–Test 1 Initial loading stiffness versus drift

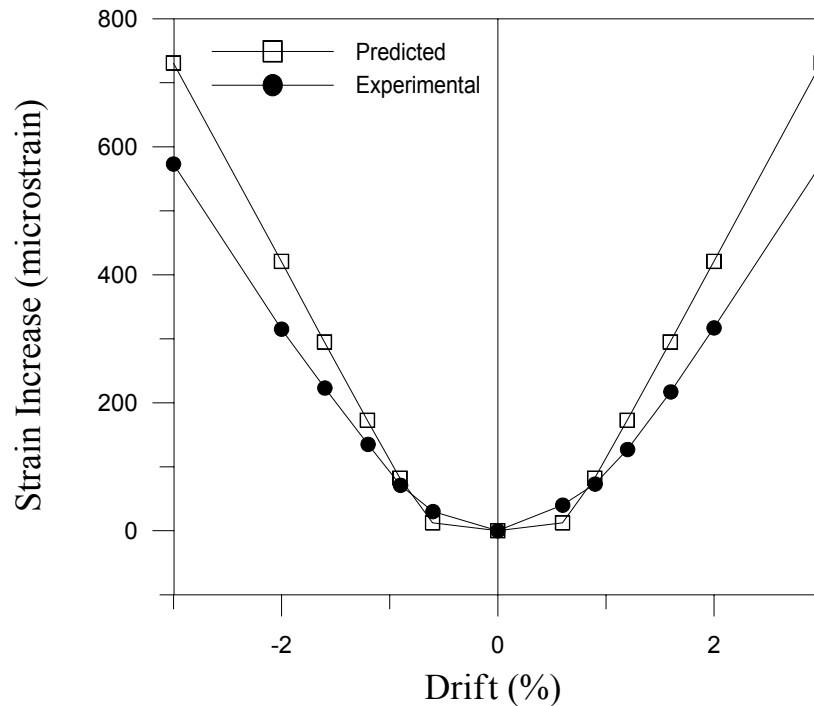
Figure 4.30 JH1–Test 1 Predicted and experimental tendon strain increase

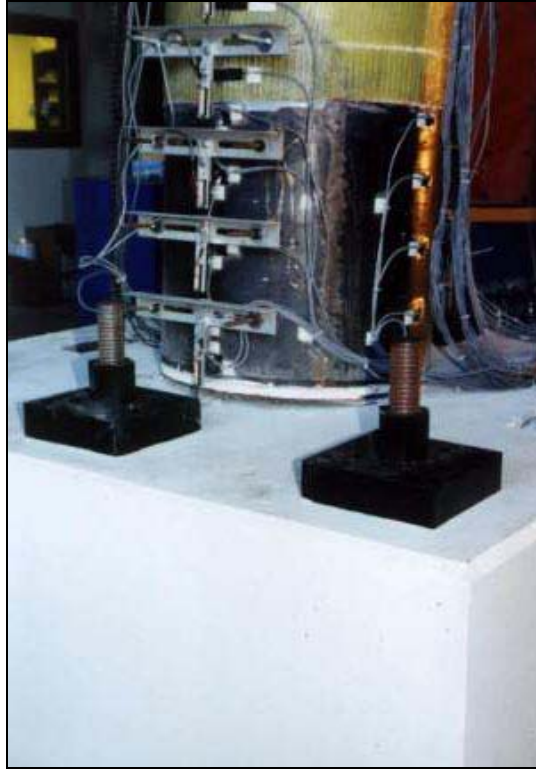
Figure 4.41 JH1 –Test 2 Crack at column base at 6.0% drift

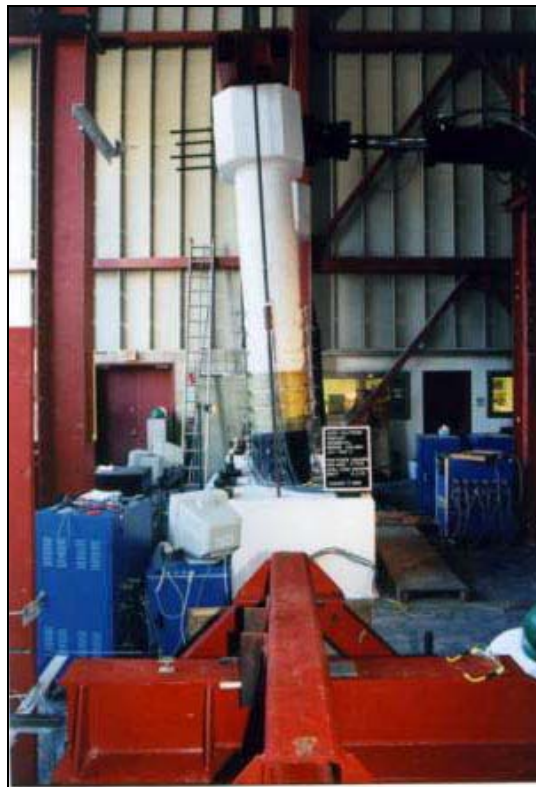
Figure 4.42 JH1 – Test 2 Overall view of specimen at 6.0% drift

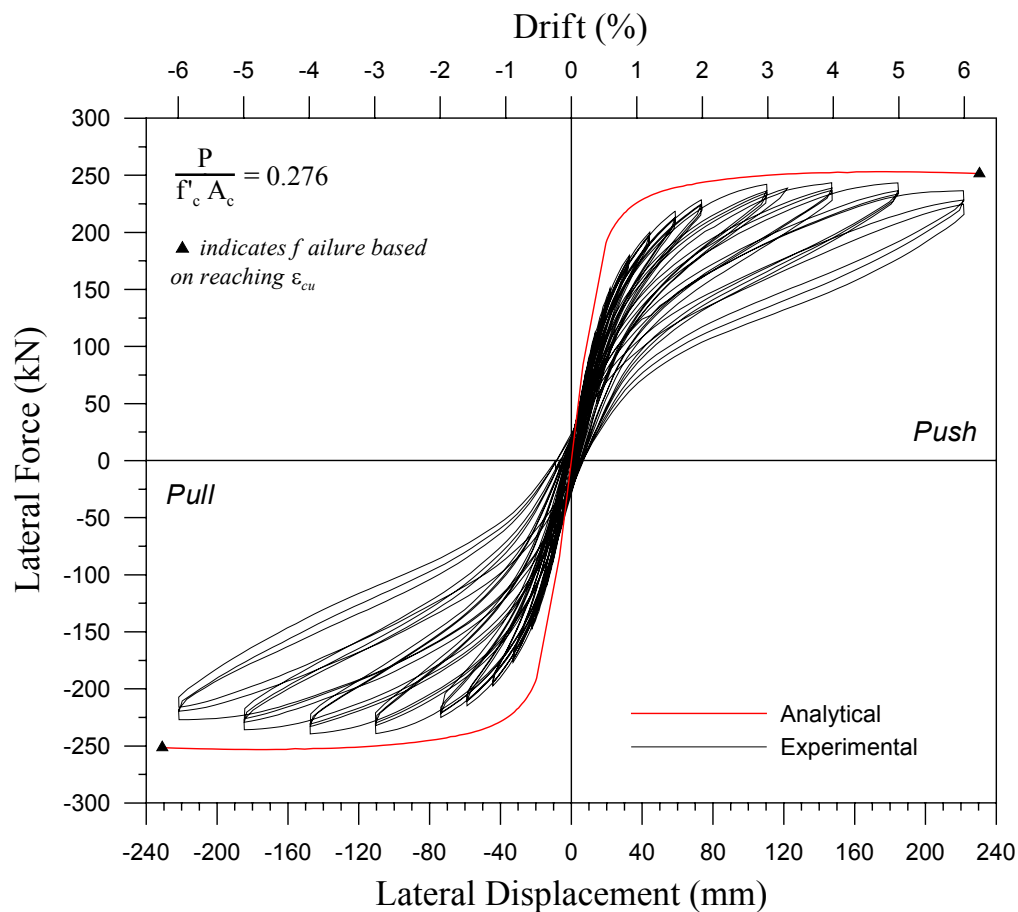
Figure 4.43 JH1-Test 2 Force-displacement response

The lateral force-displacement response for the second test of specimen JH1 is shown in Figure 4.43. The response of the column was stable and symmetric up to the maximum imposed drift of 6.0%. Equal strengths were achieved for the push and pull directions of loading. The beginning of significant non-linear response initiated at a force of around 200 kN - a force level which corresponds to approximately 2.2 times  $P_1$ . The maximum column strengths occurred at a drift of 4.0% and were 243.5 kN and -239.5 kN for the push and pull directions, respectively. Degradation of the column strength was minimal at higher drifts, with a decrease in capacity of 3% and 5% observed at the maximum imposed drift for the push and pull directions.

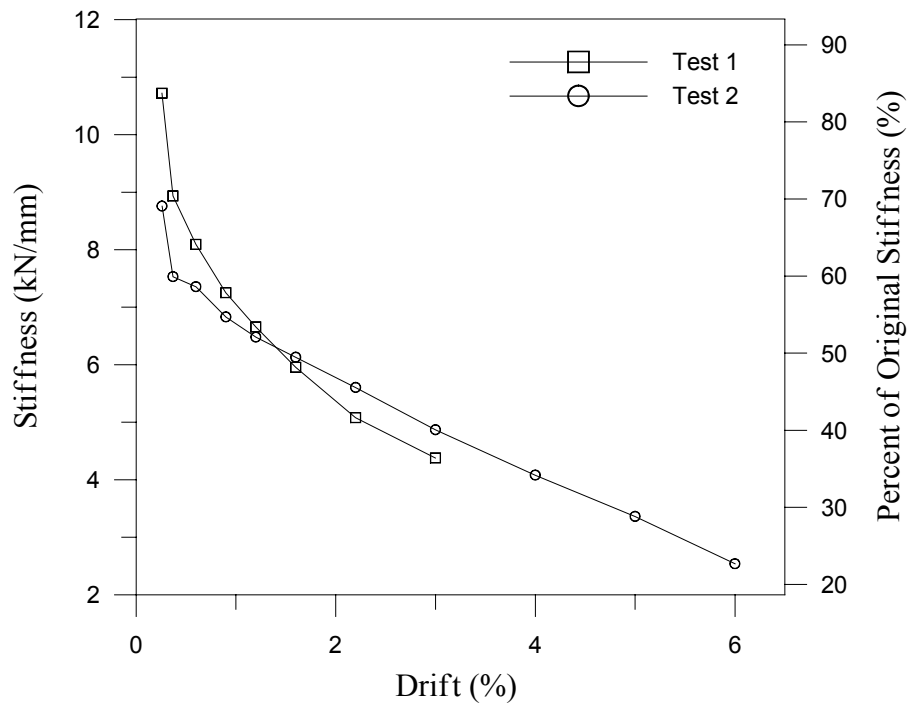
Figure 4.44 JH1 – Test 2 Initial loading stiffness versus drift

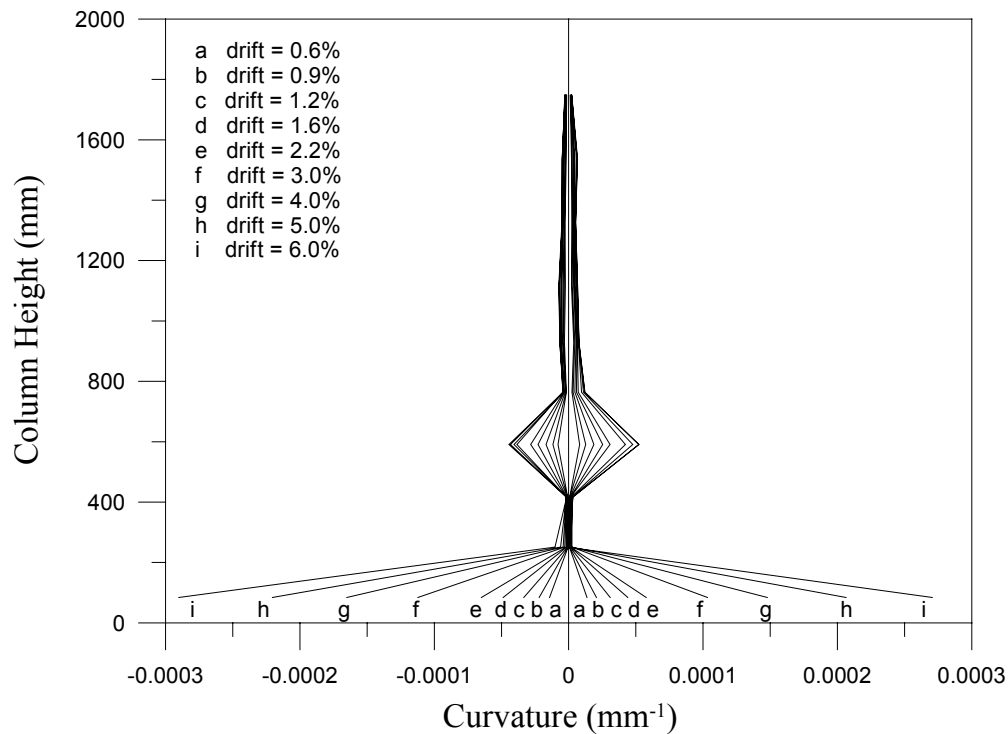
Figure 4.46 JH1-Test 2 Curvature along column height

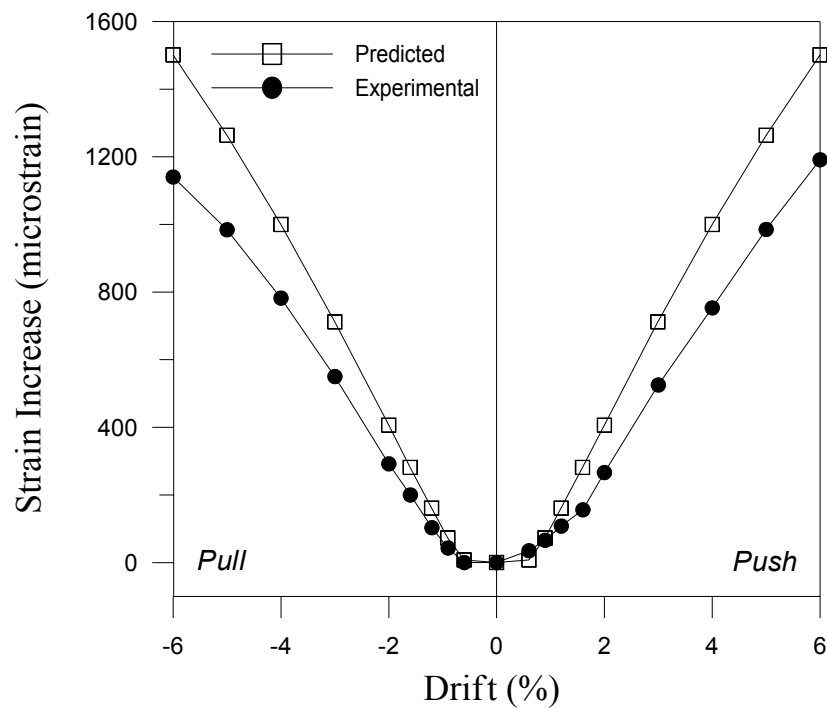
Figure 4.47 JH1 – Test 2 Predicted and experimental tendon strain increase

The predicted and experimental tendon strain increase curves are given in Figure 4.47. The analytical model over-predicts the strain increase by approximately 30% on average. Reasons given in Section 4.5.3 for the discrepancy between observed and predicted strain increase for the first test of JH1 also apply for the second test.

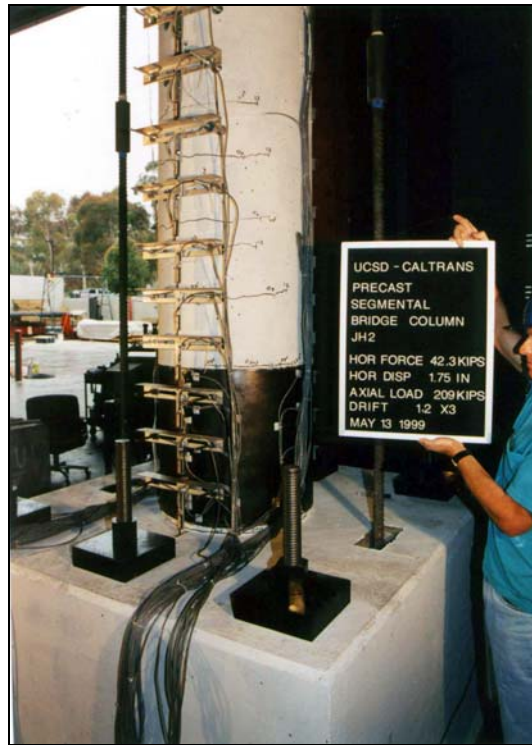
Figure 4.59 JH2 – Test 1 Crack pattern at 1.2% drift

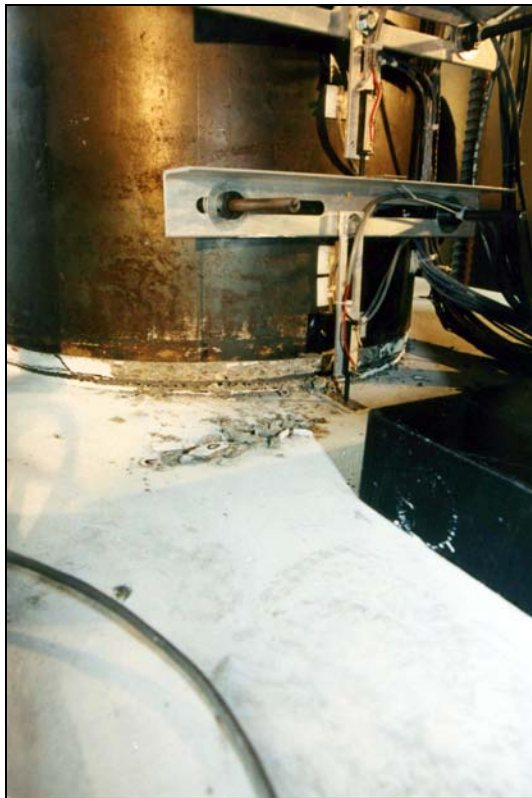
Figure 4.60 JH2 –Test 1 Damage below jacket at 3.0% drift

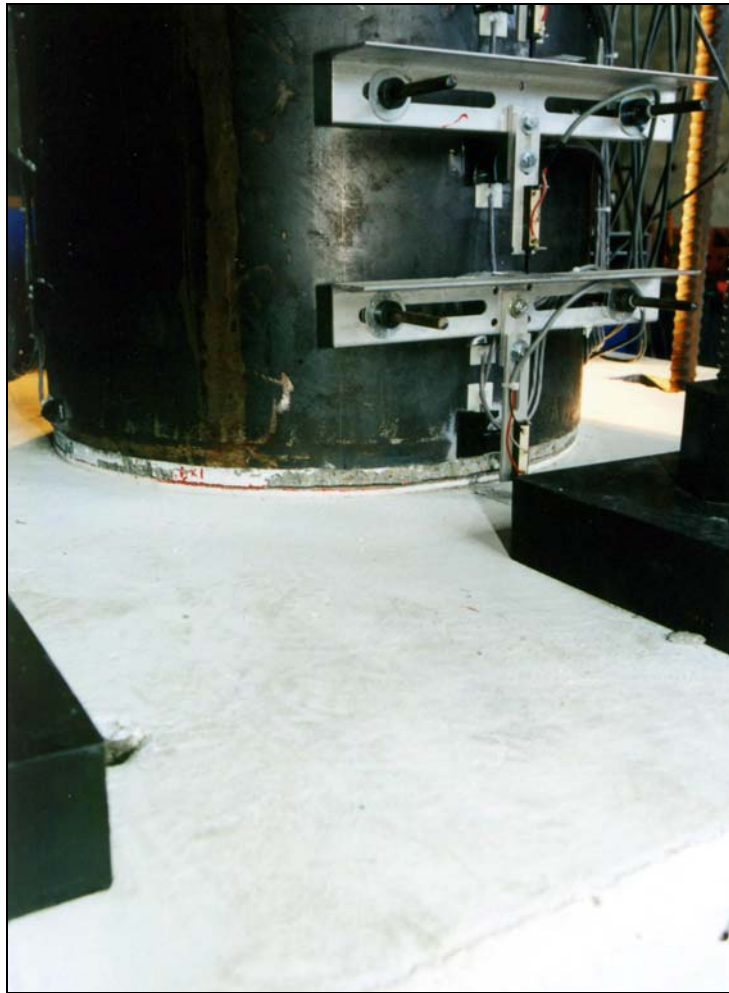
Figure 4.61 JH2 – Test 1 Residual crack at column base at end of test
